Clinical Bulletin J. LAHA, Vol. 2020, No. 1; p. CB06.

## **One-Shot Venous Lake Removal**

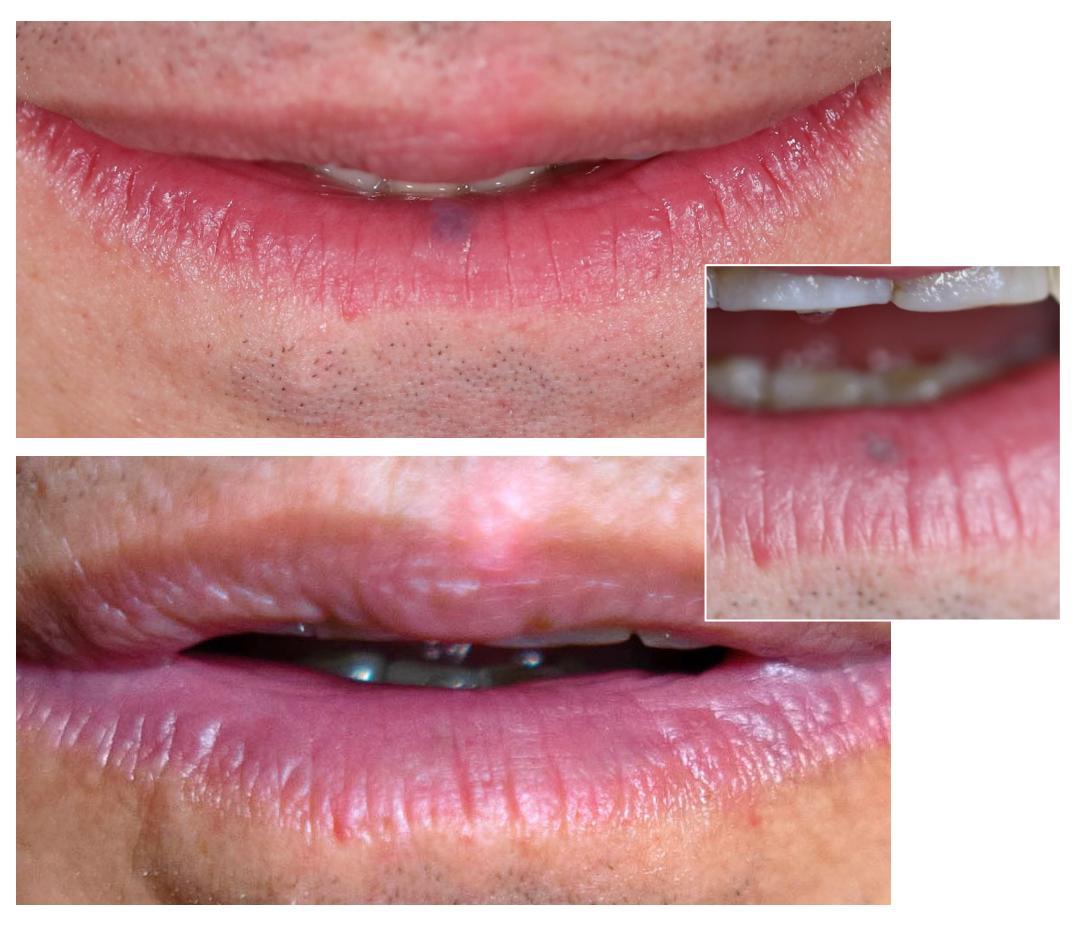
Before, immediately after and 4 weeks after the treatment.

A male patient came to our clinic for a non-laser related procedure. During the visit we informed him that we can remove his lower-lip venous lake. He decided for the treatment despite not having any "functional" problems. Before starting the procedure, the lower lip area was cleaned and dried. An ice cube was placed on the lip for 5 s in order to precool the area. The SP Dynamis Nd:YAG laser was used with the above-mentioned parameters. Only one shot was needed to get the proper tissue reaction, i.e. the lesion contracted and darkened. No special post-treatment care was needed, and the patient was instructed to put some repairing cream on the area if needed. The patient was satisfied with the treatment and sent a follow-up photo 4 weeks after the treatment.
